Holden are the first Australian manufacturer to produce a vehicle with a composite (modular) radiator support panel. The VE Commodore features this new design which was developed with input from the IAG Research Centre's staff. It is the product of substantial computer aided design (CAD) focussed on the key objective of reducing collision repair time and subsequent costs.

The information below details the removal and replacement procedures of the front bumper bar, module, rear bumper, and boot floor pan.

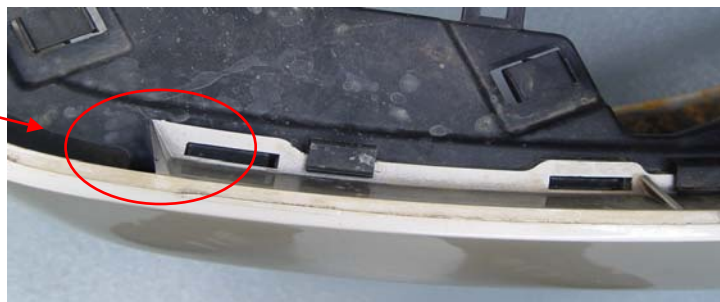
Photo 2

Step 5 The bar cover clips into a stay below each headlamp. The tabs can be released by wedging a screw driver between the stay and the cover and gently levering apart. This can be seen in the encircled area in photo 2.

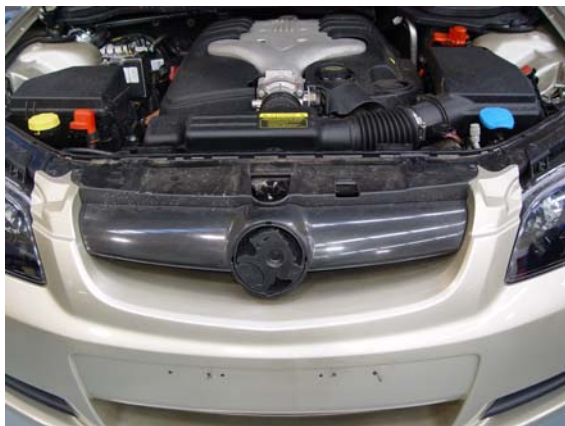
Photo 3

Note - The grille removes with the cover and detaches separately from the vehicle .

The bar cover is now ready to be removed.

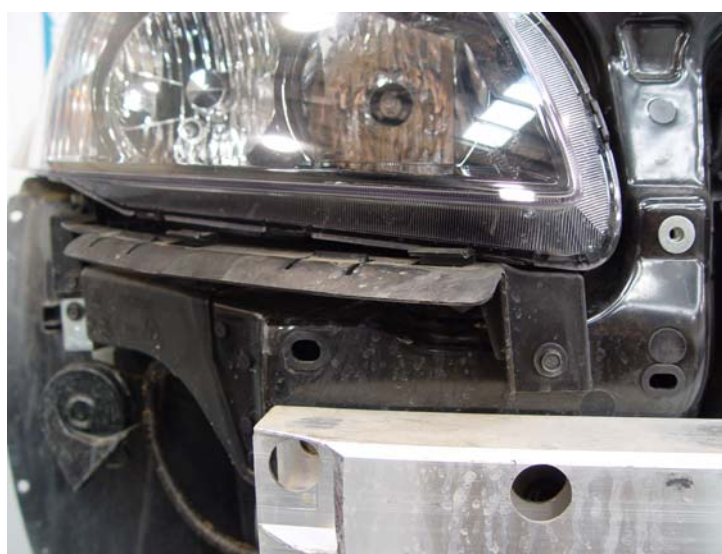
Photo 4 shows the stay's location (right side) on the vehicle with the bar removed. It's retained with 2 x 6 mm bolts and needs to be removed to allow access to the headlamp bolts.

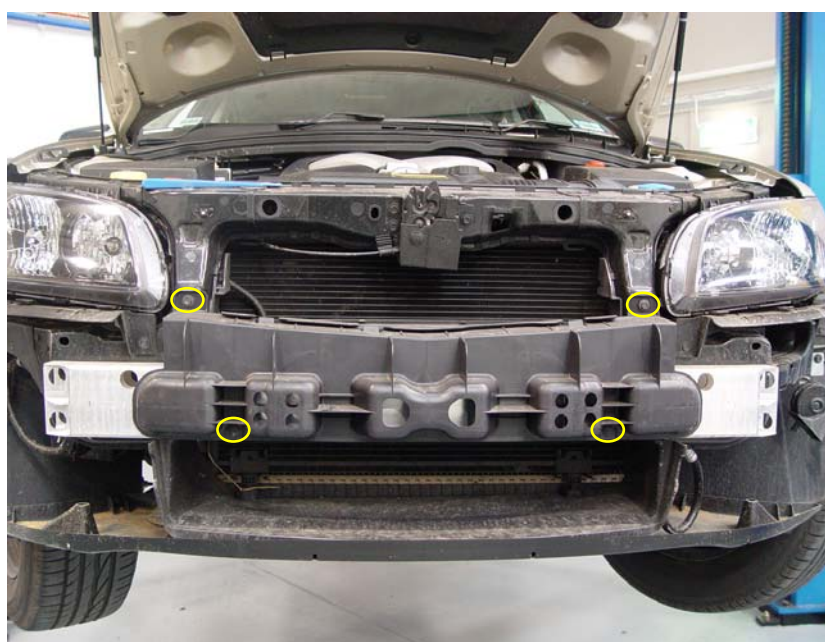
Photo 5

Step 6 The front bar impact absorber is attached to the reinforcement by a 6 mm bolt and clip either side. Their location is shown in the encircled area in photo 5.

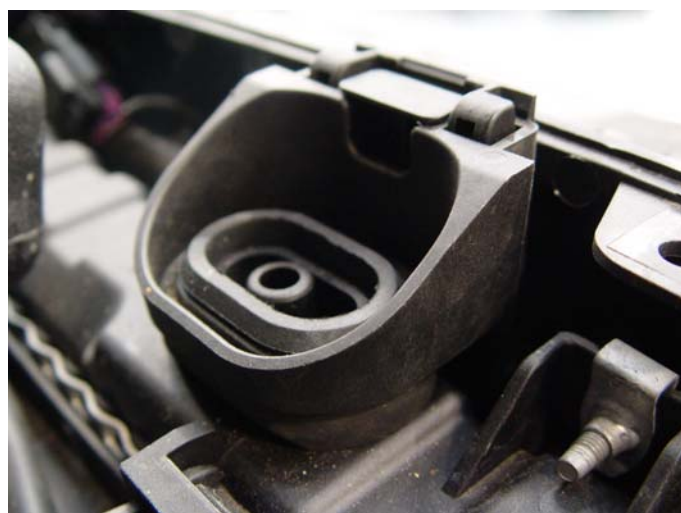
Photo 7

Step 5 The radiator is secured at 4 points; at the bottom - the left and right sides of the engine cradle and at the top - the left and right sides of the module. To release the radiator from the module, place a screw driver under the tab as shown in photo 7 and manipulate upwards.

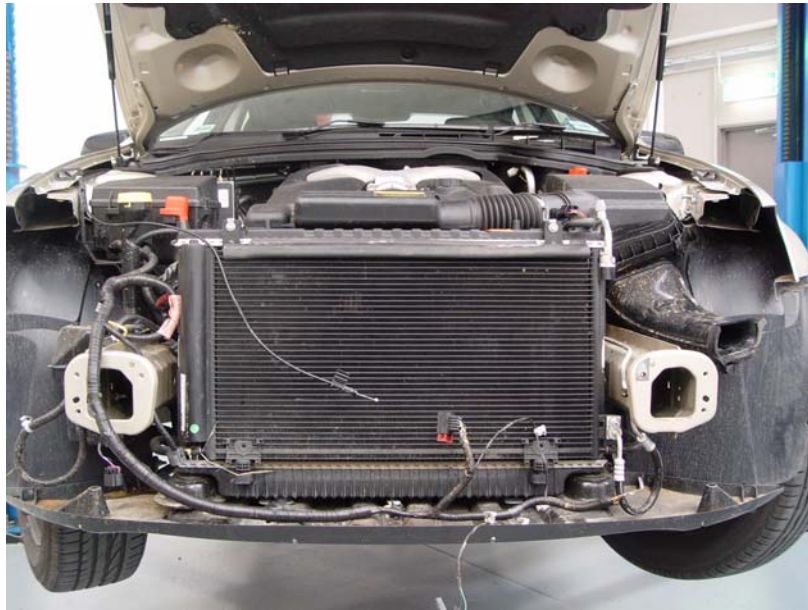
Photo 8 shows the front of the vehicle with the module removed.

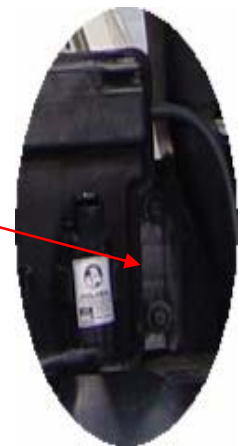
Photo 9

Remove the 2 bolts either side of the module to release the bar reinforcement.

Remove the 2 bolts on the vehicle's right and the single bolt on the left to release the washer

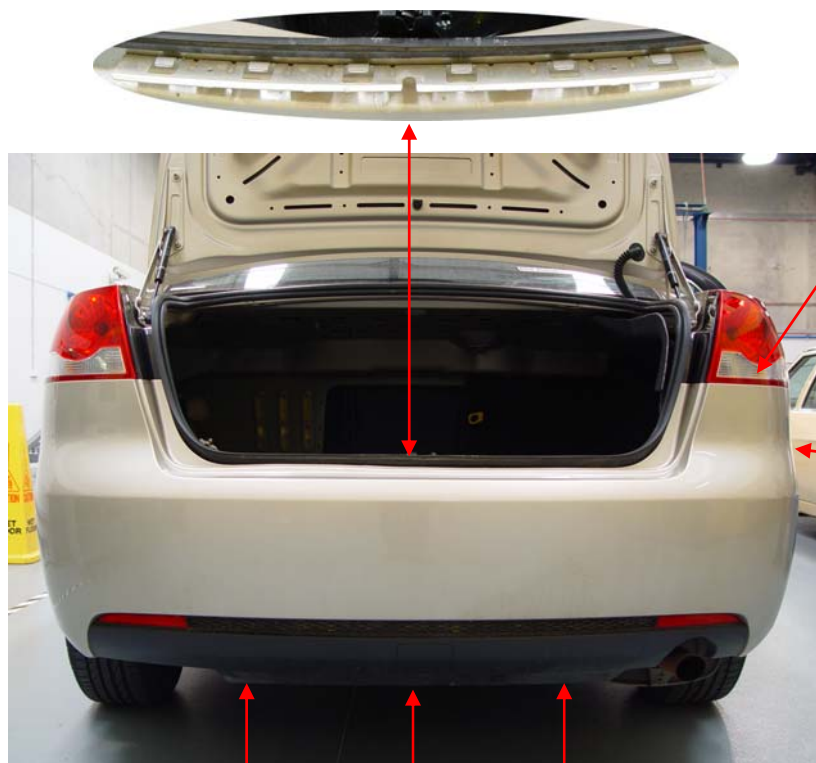
Photo 10

*NOTE - Rear bar can be removed with the tail lamps left in the vehicle.

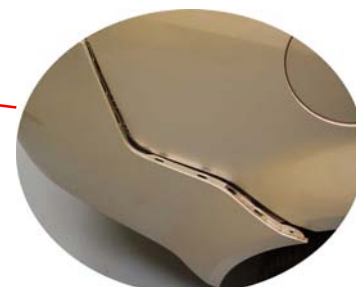
Lamp removed to show how the cover is retained at this point. Clips will release when slight pressure is applied.

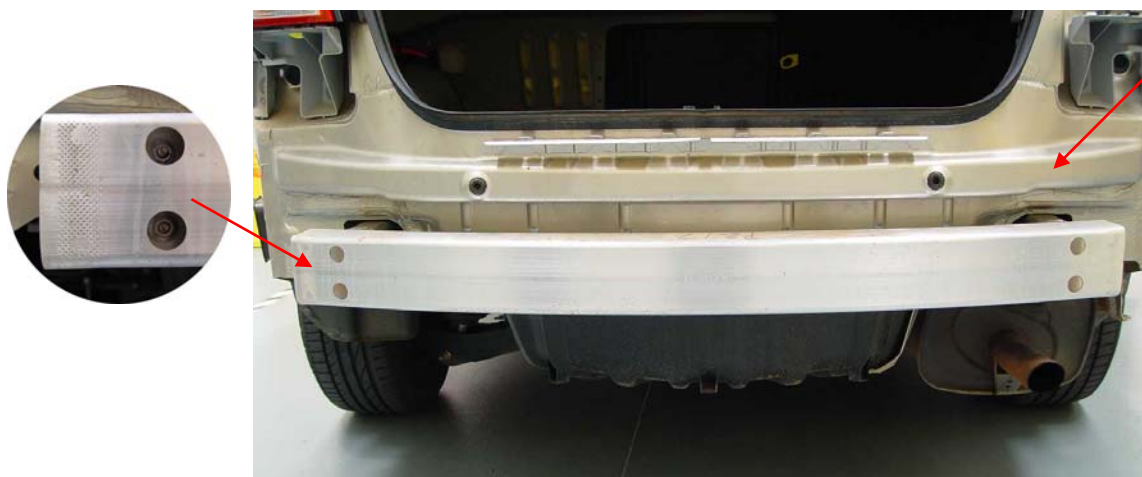
Photo 11

The reinforcement is retained to the brackets with 2 x 8 mm nuts either side of the vehicle. The brackets are retained to the vehicle body with 2 x 8 mm bolts.

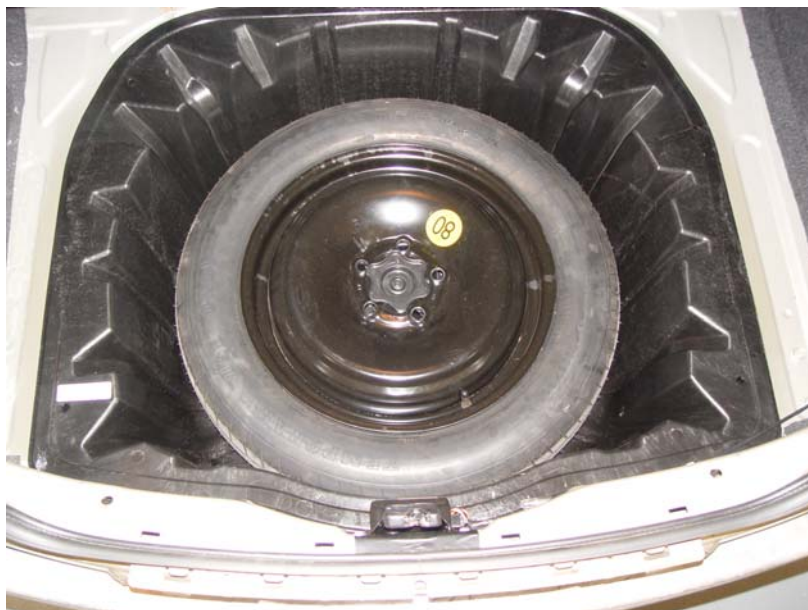
Photo 12

The boot floor/spare wheel well is urethaned in position. No time has been allowances have been constructed for its removal however, a time similar to windscreen replacement could be considered.

The battery is located in the nearside of the boot compartment as shown in photo 12.

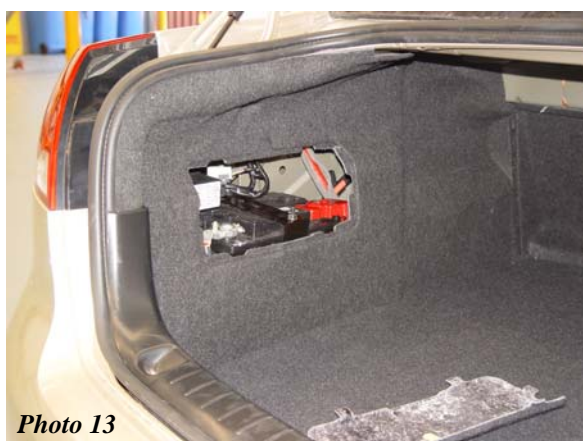
Photo 13

The engine may be jump started by connecting to the 12-volt battery jumper cable connections located in the near side of the engine compartment.

Positive jump start connection

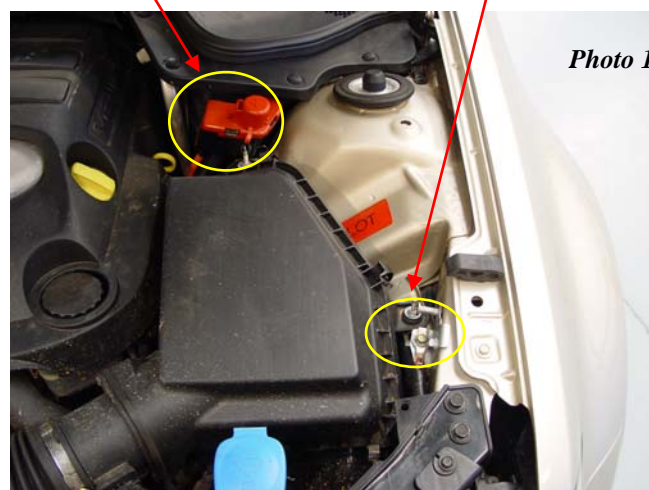
Photo 14

Negative jump start connection
